# ENGINEER SECTION HQ.EIGHTH ARMY

ENGINEER SECTION, HEADQUARTERS EIGHTH ARMY

#### in May 1945

# JAPANESE DEFENSIVE POSITIONS TALISAY-TANKE LANDING BEACH AREA, CEBU ISLAND, P.I.

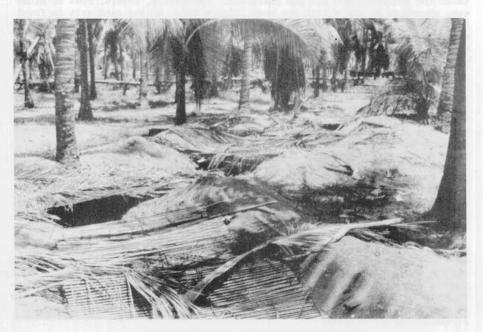
DETAIL OF TYPICAL SECTION OF TRENCH, TALISAY-TANKE BEACH AREA

shelters back of the beach, apparently designed for CP's, but no artillery, mortar, or AT gun positions were discovered. Trenches were of simple standing zig-zag or wavy types (Figure 2), generally not revetted, and with several splinter-proof covered bays. The concrete pillboxes and shelters ranged from 7 inches to 3 feet in thickness; coconut log emplacements were from one to four logs in thickness. Splinter-proofs generally consisted of one to two inch lumber sheathing covered with sand or sand bags (See Figures 3 - 8).

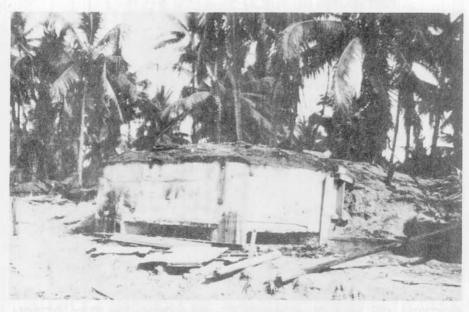
Photo of Pillbox in Above Sketch

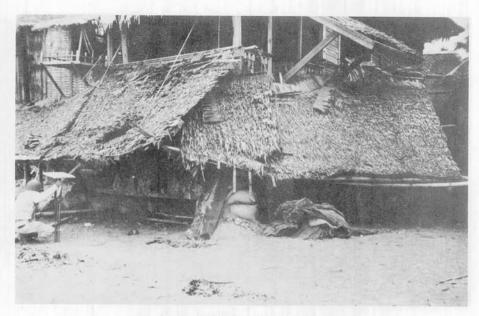
FIGURE 5 - PAGE 8

Photo of Pillbox in Figure 4

Another View of Pillbox in Figure 4

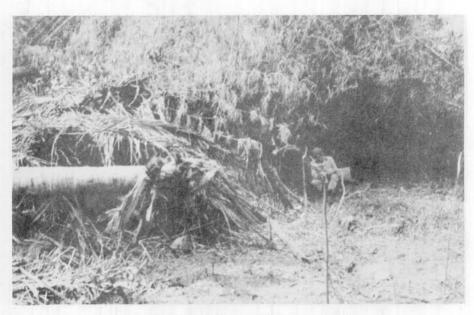
Log Shelter, Talisay - Tanke Beach Area

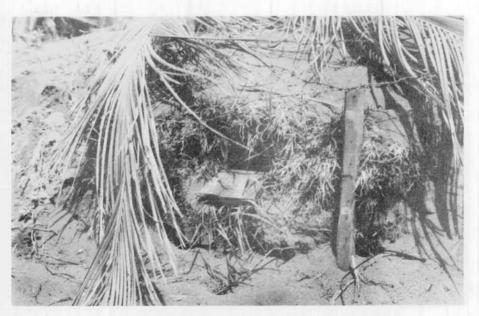
Splinter Proof Firing Position, Talisay - Tanke Beach

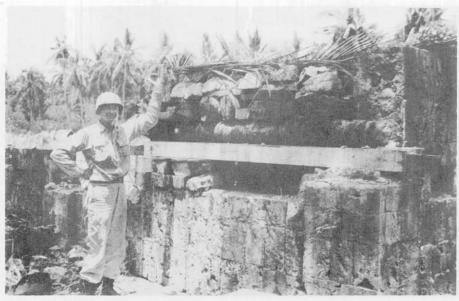
Pillbox in Corner of Stone Wall, Talisay - Tanke Beach (See Sketch Above)

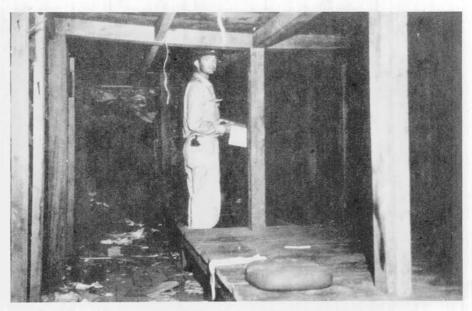
Interior of Shelter, Talisay - Tanke Beach (See Sketch Above)

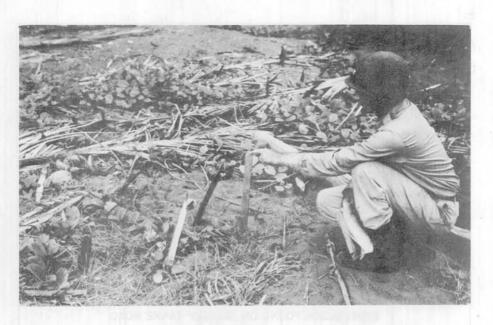
- 5. Anti-personnel obstacles, consisting of wire entanglements and short, pointed bamboo strips were employed (Figure 17). One band of wire obstacles extended the entire length of the beach. Included was one short section of underwater wire (Figure 18), which was completely submerged only at high tide. Another strip of low wire placed in the surf covered an 880 foot frontage along the beach (Figure 18). A shallow field consisting of rows of two feet long pointed bamboo strips extended for about 750 feet in front of one section of the forward line of emplacements.

Bamboo Strip Anti-personnel Obstacle, Talisay - Tanke Beach Figure 17

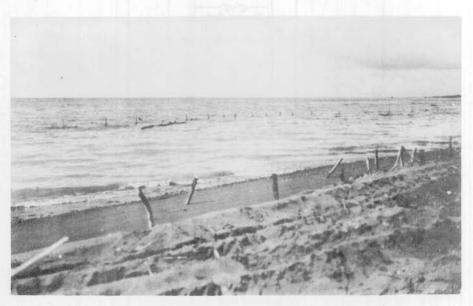
Underwater Wire and Wire in Surf, Talisay - Tanke Beach Figure 18

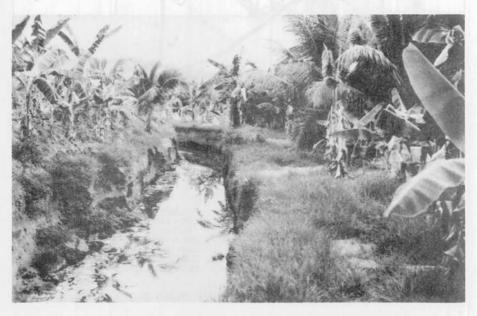
AT Ditch and Dragon Teeth, Mananga River Bridge

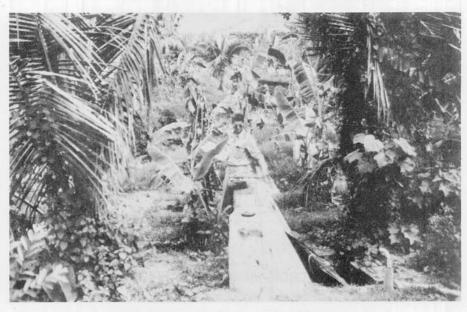
Dragon Teeth, Mananga River Bridge (See Figure 22)

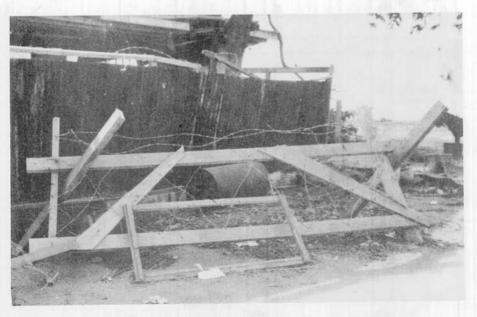
- a. Road shoulders and roadways were mined with aerial bombs, shells and yardstick mines (See Figure 24).
- b. Some street blocks consisted of large buried marine mines or depth charges behind movable knife-rests of timber and barbed wire placed across the street (See Figure 25).

Type of Knife-Rest Used in Cebu City Street Blocks Figure 25

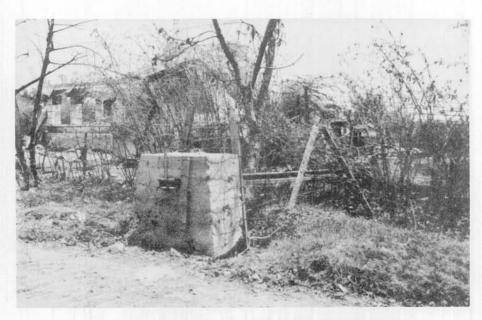
- c. Railroad rails supported by heavy concrete posts or logs and extending across streets were used as blocks. These generally were tied in to stone buildings, walls, or other natural flanking obstacles (See Figure 26).

Remains of Steel Rail Type Street Block, Cebu City Figure 26

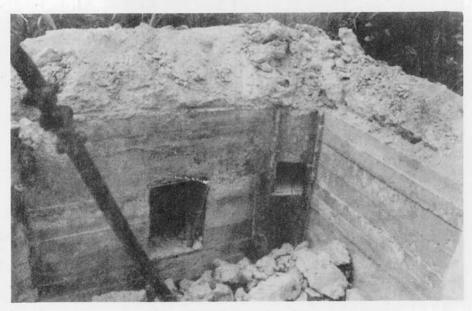
Many road blocks and street tangents were covered by MG and rifle positions of the open parapet, splinter-proof, or concrete pillbox types; or by MG and rifle positions built into buildings and walls. For characteristic positions, see Figures 29 & 30.

Concrete Pillbox, Cebu City (See Sketch Above)
